# Public Roads

- Concrete Pavements on the German Autobahnen. . . 65
- Analysis of Rectangular Reinforced Concrete Sections Subjected to Direct Stress and Bending in Two Directions . . . . . 80

THIS report presents the results of an inspection of concrete pavements on the German motor-road system made by the authors during the summer of 1947 under instructions from the Commissioner of Public Roads. The inspection was made with the object of determining first, in what respects, if any, the German pavements are superior to ours; and second, what features of German design and construction practice, if any, can be adopted with profit by American engineers.

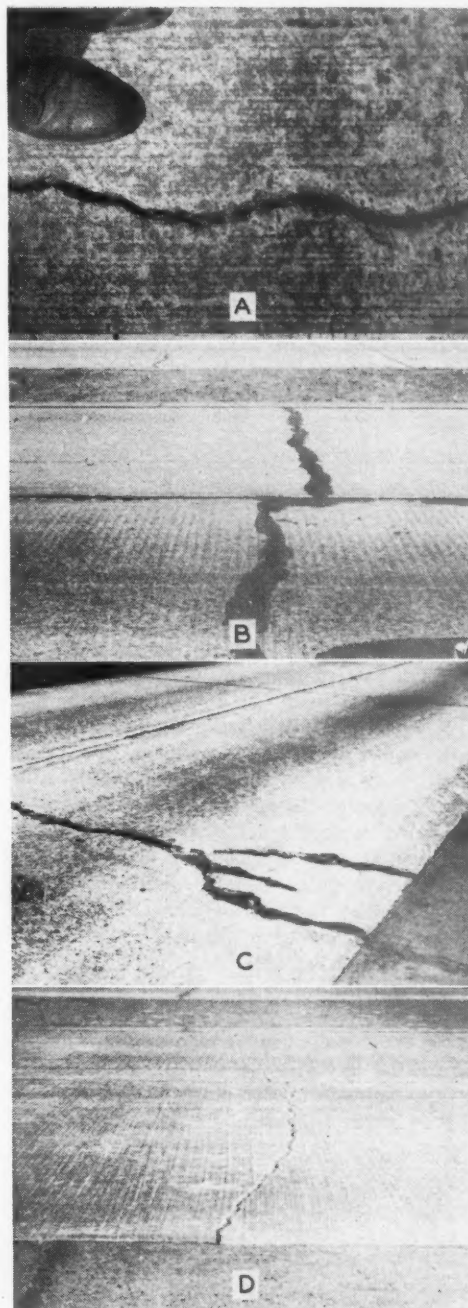
Transverse cracking was common and was not confined to any particular part of the system. There seemed to be no relation between transverse cracking and terrain or soil conditions. In most instances the cracks were closed and were not discernible at speeds normally traveled by automobiles. In some cases the cracks were open and the expansion joints had closed. This condition was noted on a section just north of Göttingen, near Kassel. Transverse cracking seems to be most pronounced on the route from Hannover to Frankfurt through the Ruhr Valley, from Frankfurt to Kassel, and from Frankfurt toward Heidelberg. The cracking shown in figure 10 is typical of that observed.

Figure 10.—Transverse cracking was common throughout the system.

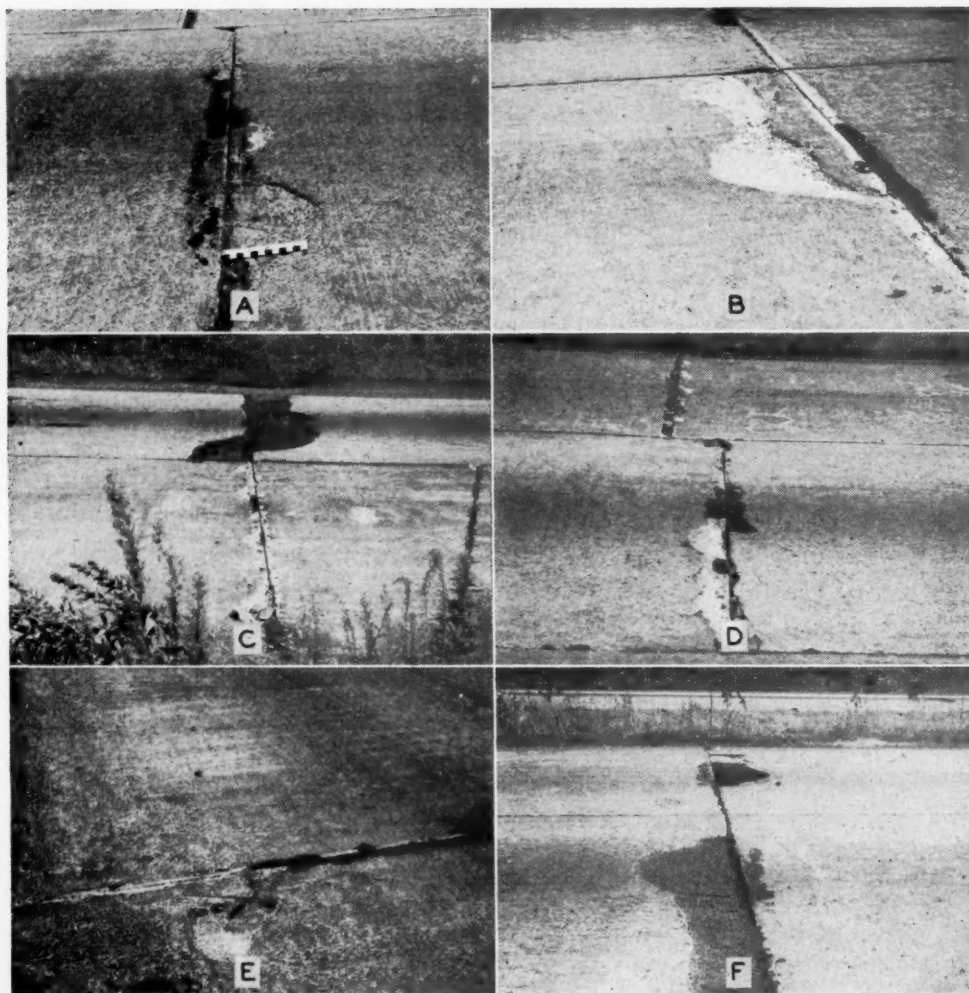
Spalling at transverse and longitudinal joints was found principally in the area around Frankfurt. At the transverse joints this appeared to be due in most instances to the infiltration of sand and other incompressible debris into the joint and the subsequent over-stress of the concrete upon expansion of the pavement. Figure 11 illustrates the spalling at joints in the vicinity of Frankfurt.

Figure 11.—Spalling at joints occurred principally in the vicinity of Frankfurt.

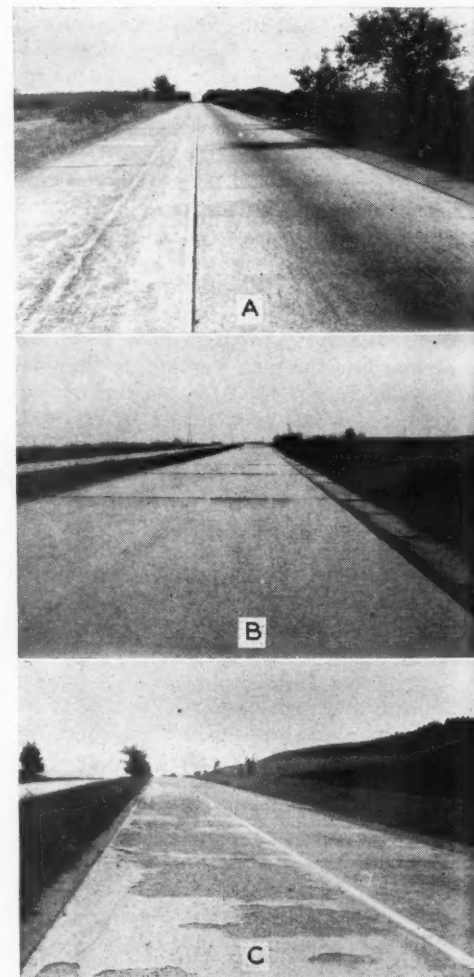
Faulting at joints and at transverse cracks, in most instances less than  $\frac{1}{4}$  inch, was observed in areas where there was evidence of a considerable amount of traffic. At a location approximately 50 miles west of Kamen faulting of joints in the outside lanes of the pavement was found to be  $\frac{1}{2}$  to  $\frac{3}{4}$  inch. Faulting in the outside lane in the Ruhr-Frankfurt area is shown in figure 12A. The photograph was taken with the camera facing in the direction of the traffic and it should be noted that the expansion joints in the left lane, which had not faulted, are visible while those in the right lane had faulted sufficiently to be obscured.

Figure 12.—(A) Joint faulting in the left lane (Ruhr-Frankfurt). (B) Warping resulted in high joints (Ruhr-Frankfurt). (C) Surface scale was seen only on the München-Salzburg route.

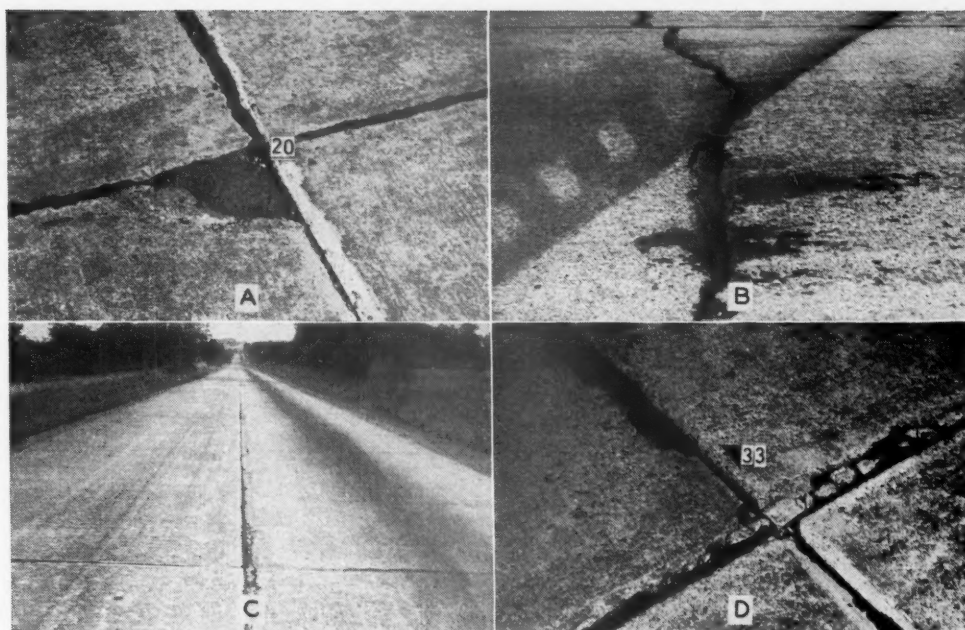
small corner break which has been patched is shown in figure 13A.

Some faulting and some spalling were observed at the longitudinal center joints. In many instances the longitudinal center joint was crooked. The longitudinal joints shown in figures 13C and D are typical of the condition frequently observed.

Figure 13.—(A) A patched corner break (Frankfurt-Stuttgart). (B) A large random crack (Hannover-Ruhr). (C, D) Typical faulting of longitudinal joints (Ruhr-Frankfurt).

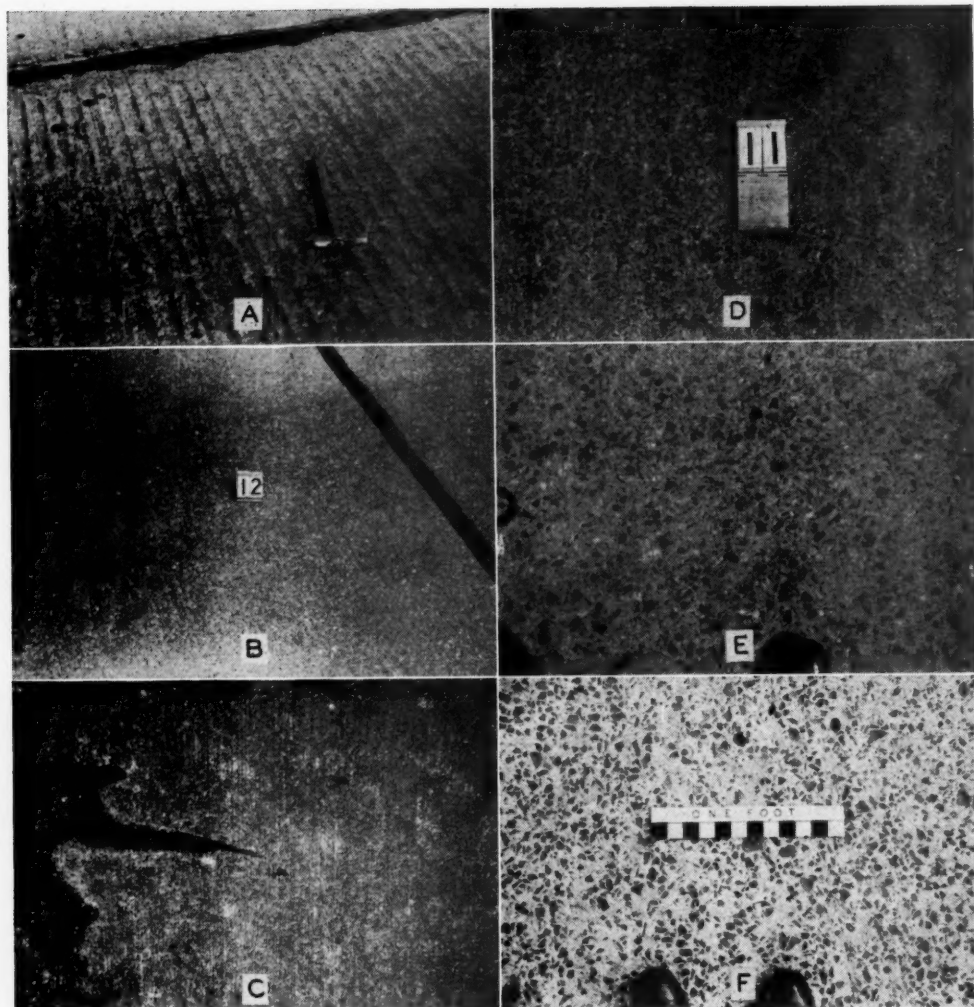
A characteristic feature of the pavement surface is the general absence of the rather heavy mortar top which we frequently leave on our roads and which so often scales off, leaving the surface rough and unsightly. An examination of the surface indicated, in most instances, the use of a mix that contained just enough paste to fill the voids in the aggregate and leave a small excess for finishing. Surfaces were dense and compact, with the coarse aggregate either just below the top or actually exposed in some degree. Typical illustrations of variations in the surface texture are shown in figure 14. Figure 14A is a view of a surface on which the screed marks are still showing. The corrugations are quite shallow and are about 1 inch apart. This particular photograph was taken just east of the Bad Oeynhausien interchange on the road to Hannover. Other sections showed the same condition, particularly on the inner lanes which, of course, carry less traffic. Figure 14B illustrates a fine-grained sand finish texture which was also noted in several places. The photograph was taken on the same road as figure 14A and about 5 miles east of the interchange.

Figures 14D-F illustrate varying degrees of coarse aggregate exposure. Figure 14D indicates the type of surface about 7 miles south of Frankfurt on the road to Stuttgart; figure 14E a section of the Hamburg-Lübeck road; and figure 14F, a section between Hannover and Berlin at kilometer post 194. Note in the last-mentioned illustration that coarse aggregate up to 1 inch in size, which is close to the maximum size used in the top course, is exposed. Many of the exposed aggregate surfaces are smooth, with a terrazzolike texture, probably the result of slight

surface wear. In many places this type of surface was noted in the center of the traffic lanes (particularly the outside lane) with the original thin mortar surface showing at the extreme edges. In other sections where the coarse aggregate was exposed, particles of the hard igneous rock protruded slightly above the mortar, producing a slightly rough surface. This condition may have resulted from the scaling off of the light surface mortar or it may have been the result of wear—it is difficult to determine the exact cause. However, it should be emphasized that the slightly rough surface is not objectionable from the standpoint of rideability. Neither should the exposure of the aggregate have any detrimental effect on the ultimate durability of the concrete, since the quality of both aggregate and concrete was excellent.

Figure 14.—(A) In some places screed marks still appear as shallow corrugations. (B) A fine-grained sand finish. (C) Black colored concrete. (D-F) Typical appearance of varying degrees of coarse aggregate exposure.

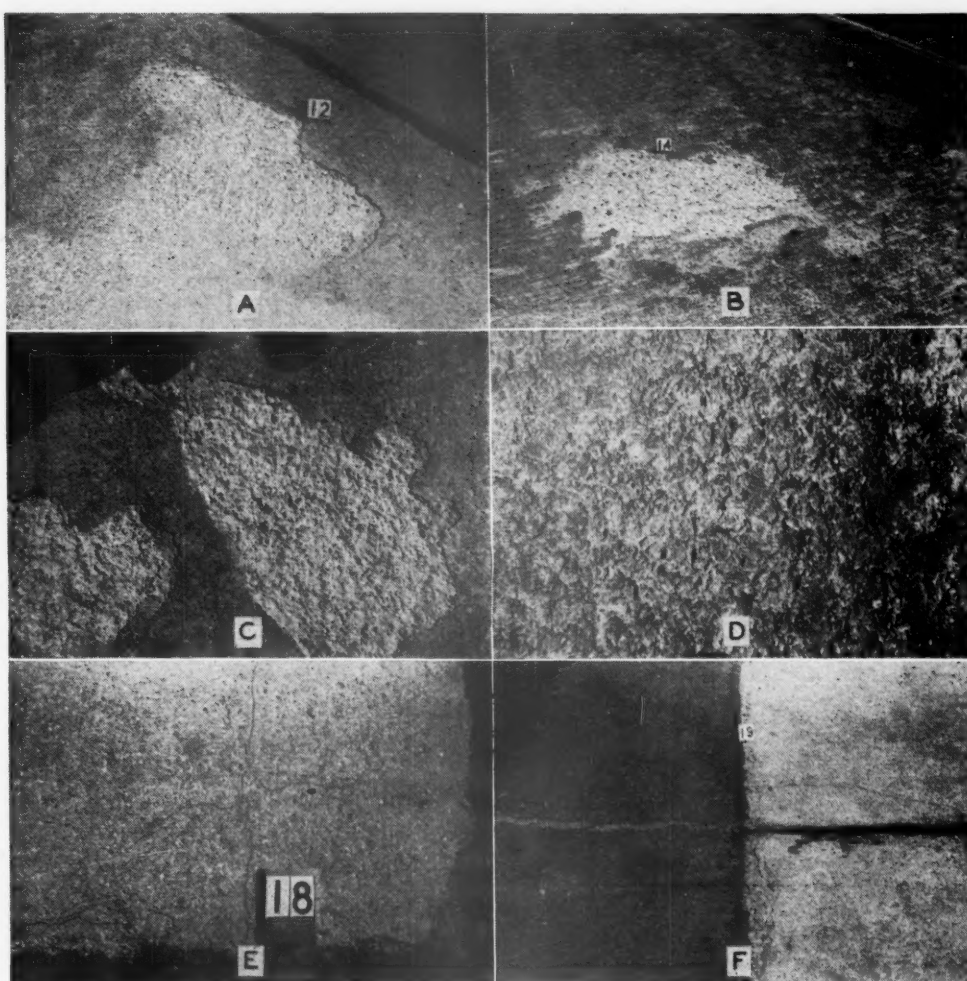
about 20 miles west of the Austrian border at Salzburg. Figures 15A and C are details showing the type of scaling that has developed on this section. It is apparently of the surface type only; that is, the concrete below the scaled areas appeared to be sound. Figures 15A and C indicate a rather heavy layer of surface mortar at this point and this fact, coupled with the possibility that the winters in this region, due to its high elevation, may be somewhat more severe than elsewhere in western Germany, may account for the scaling. However, in this connection it should be noted that, according to weather records as shown in table 1, the average January temperature at München was only slightly lower and the annual rainfall only slightly higher than for the more northern cities.

Figure 15.—(A-D) Surface scale occurred commonly on the München-Salzburg route but only isolated cases were observed elsewhere. (E, F) Incipient disintegration, revealed by D lines, was found only at one place on the system.
